BEYOND THE NORM

ECUADOR OIL PIPELINE RIVER CROSSINGS

Firm: Hydroconsult

Project: Oleoducto de Crudos Pesados

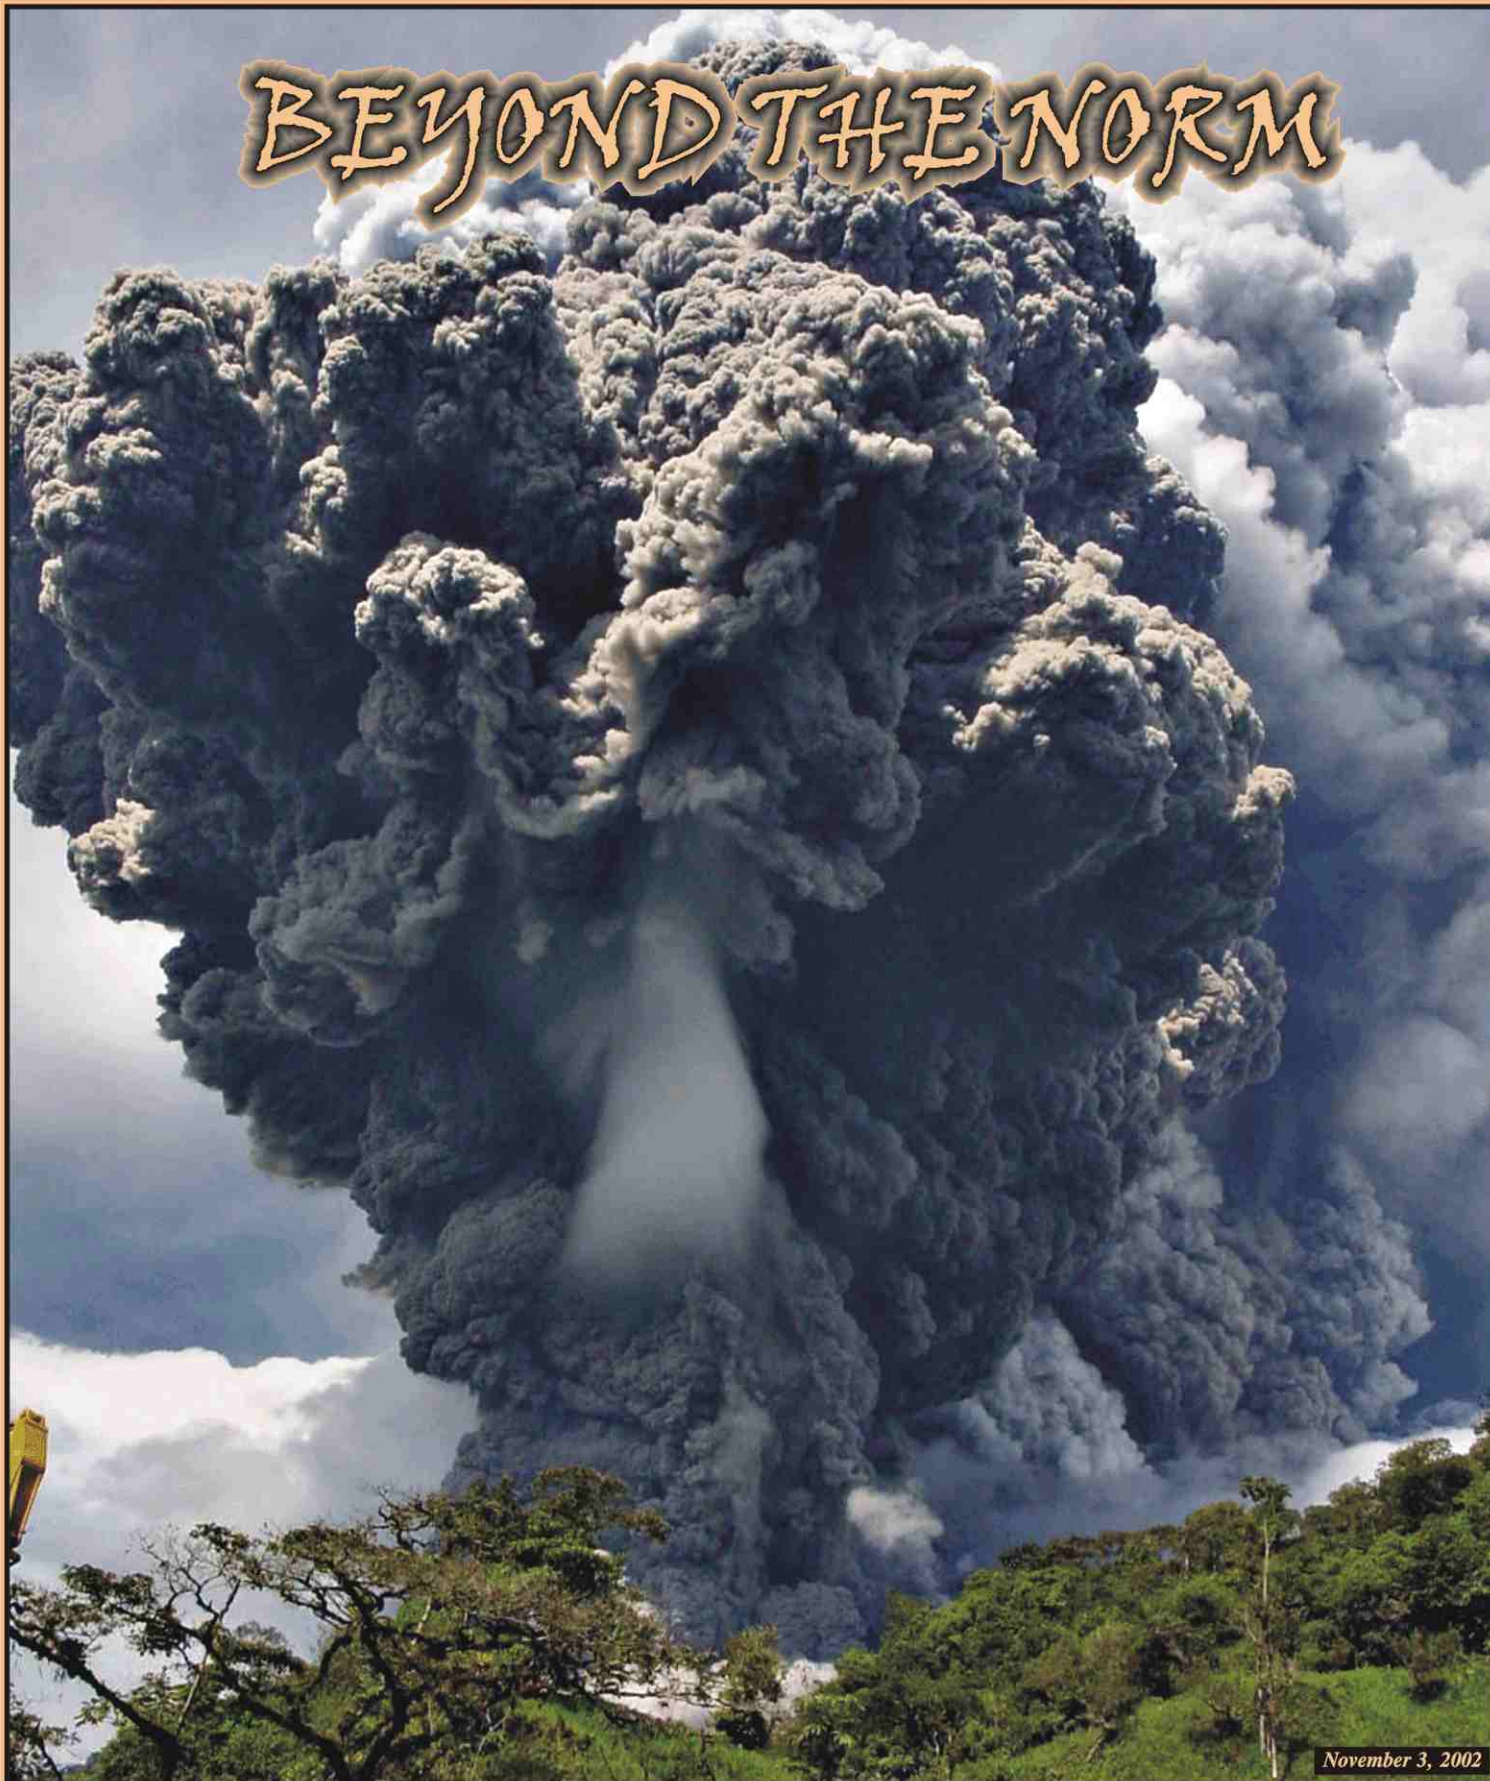
Relative Magnitude of May 5, 2003 Rio Reventador Flood

1:100 Year, Standard Alberta Criteria

1:1000 Year, OCP Criteria

May 5, 2003 Equivalent Peak

On November 3, 2002, Volcan Reventador, in a massive eruption, transformed steep stable mountainous rivers to moonscapes of erosion and deposition. Then on May 5, 2003, after construction of the OCP line was nearly completed, a 100 year rainfall mobilized the newly deposited material from the upper slopes of the volcano generating a combined water/debris flow nearly 10 times the 1000 year flood.

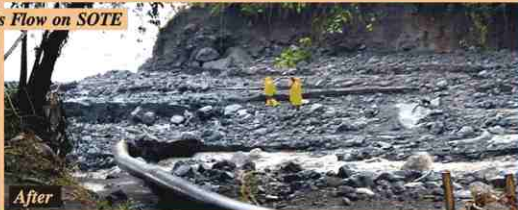
Impact of Debris Flow on SOTE

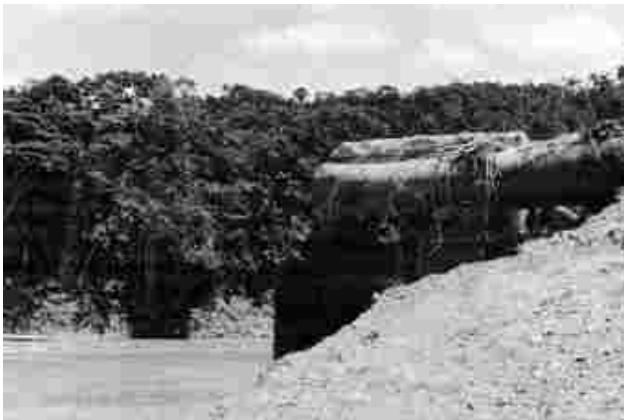
Trans-Ecuadorian pipeline (SOTE) severed by flood water, east bank of the Aguarco River. ("The March 5, 1987, Ecuador Earthquakes, Mass Wasting and Socioeconomic Effects". Natural Disaster Studies, National Research Council, 1991).

In March 1987 earthquakes of magnitude 6.1 and 6.9 occurred along the SOTE alignment in the Quijos/Reventador area. Preceding rains of 600 mm resulted in massive slope failures and landslides, some of which entirely blocked the 300 m wide Rio Quijos for short periods of

time. The subsequent overtopping and washout of the river blockages caused devastating flooding and major river changes downstream. Nearly 70 km of the SOTE line was ruptured and destroyed primarily at river crossings and where the line was close to and parallel to the Rio Quijos.

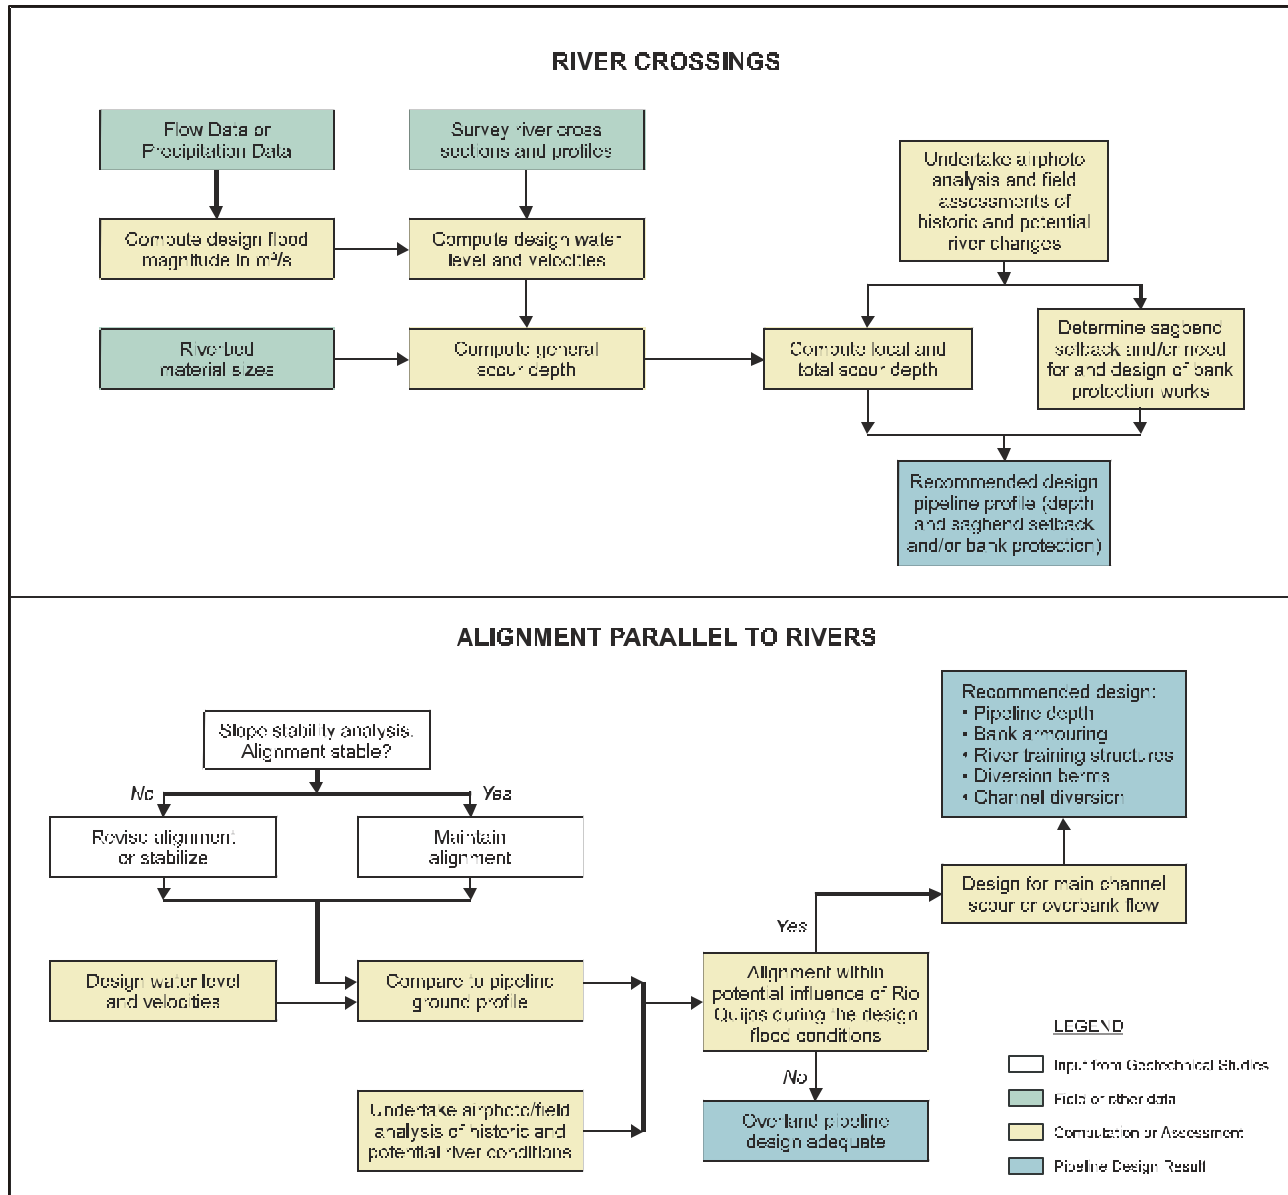
Overall Design Approach.

Deep burial, up to 6 m of cover, was recommended for segments where the OCP would be located within the potential zone of influence of a 1000 year flood on the Rio Quijos or where blockage and subsequent flash floods would cause inundation and channel changes upstream and downstream respectively. SOTE's experience with buried and elevated

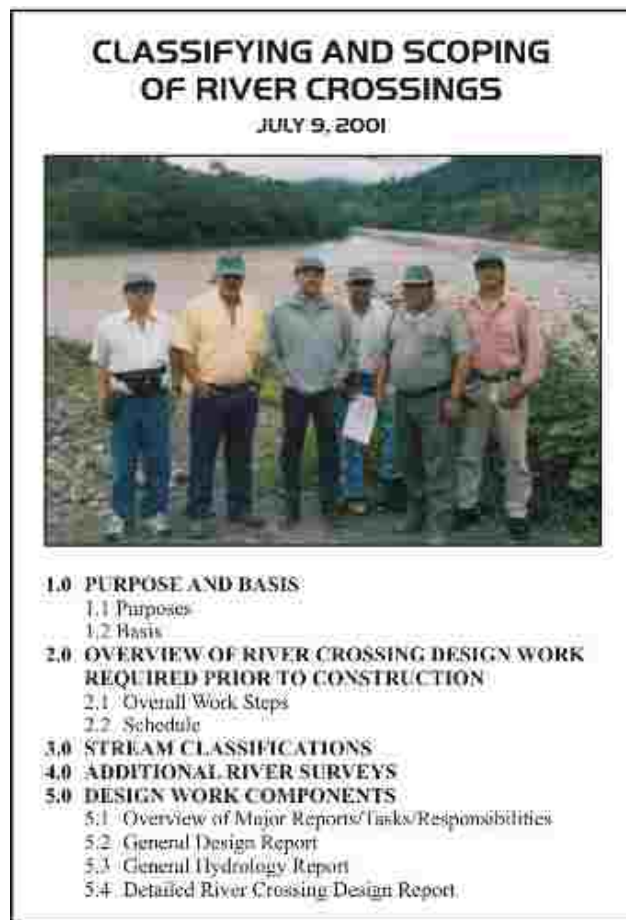
Hydroconsult's Scoping Report following a Multi-discipline field review of all the crossings.

- classify the crossings as Major, Minor and Typical. The mode, buried or elevated, was also recommended at this time.
- scope out the required detailed work to be done by the local Ecuadorian hydrologic firm,
- review the results of the detailed work.

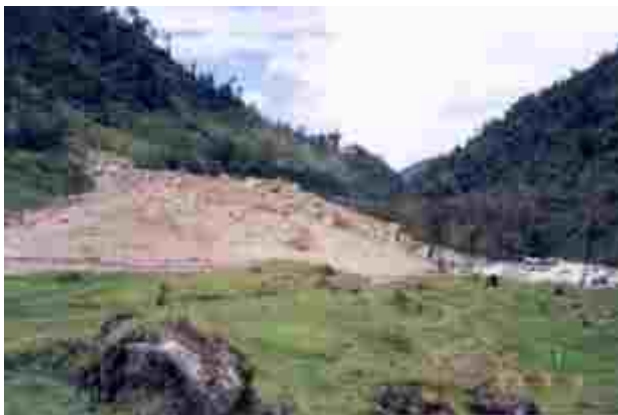
Fatal Slide Area.

In June 2001 heavy rains triggered debris flows in several relatively small tributaries to the Rio Papallacta. Residents of two homes provided overnight shelter to bus passengers stranded by the slides. In the night, a massive debris flow into the homes resulted in the death of 46 people. The SOTE line was ruptured in several locations.

As a result of these events, TECHINT's geotechnical and geologic specialists field reviewed a 15-km long segment in detail. The steep slopes precluded alignments away outside the influence of the Rio.

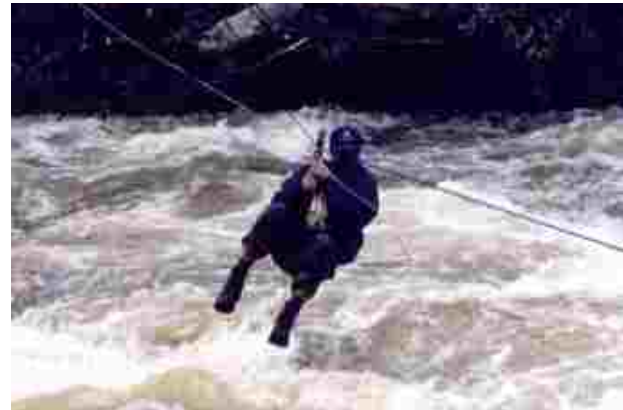
Rio Papallacta, Field Assessment Methodology

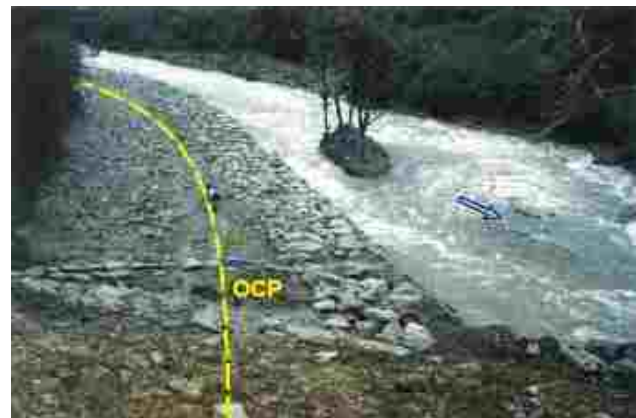
Instream section in upper reaches of Rio Papallacta. Pipeline protected by cover depth and riprap.

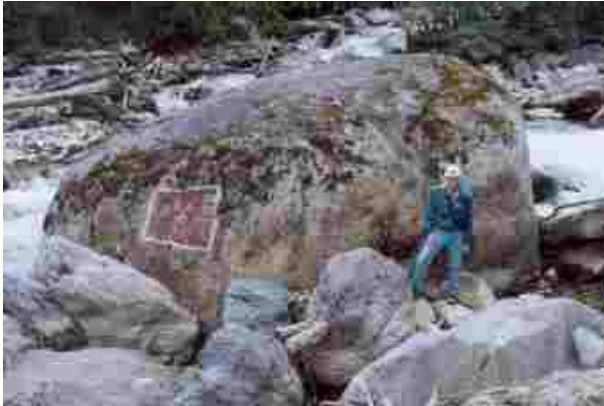
Boulder sizes in Rio Papallacta.

In reviewing the impact of the June 2001 slides, which triggered short term blockage of the Rio Papallacta, Hydroconsult recognized the general natural stability of the steep massive boulder-paved streambeds. The boulders, transported and deposited into the river valleys by extreme events, like March 1987 and June 2001, dissipate the high energy inherent in these mountainous streams. This delicate balance between the force of the river and the resistance

provided by the large boulders can be upset by construction due to the impact of excavation, blasting and backfilling.

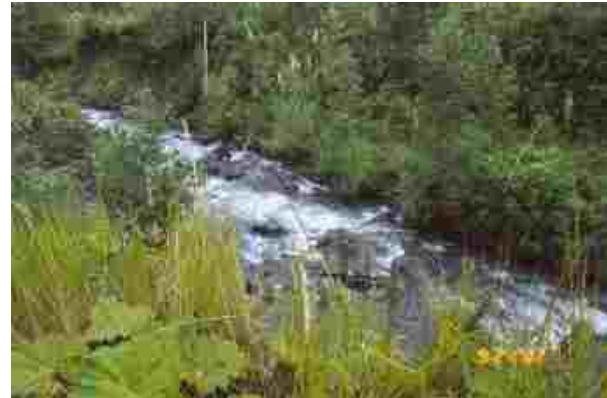
Rio Montana, Before the Eruption.

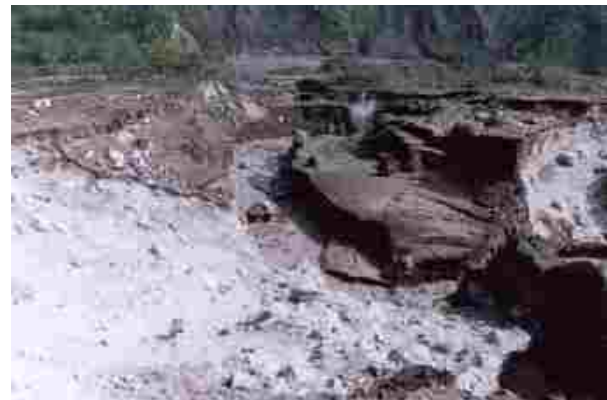
Rio Montana, After the Eruption.

The OCP alignment passes within 10 km of the Volcano and crosses the Azuela, Reventador, Montana, Marker and Piedra Fina Rios which drain its eastern flank. The November 3 eruption blanketed Quito in volcanic ash forcing an almost total shutdown of the capital city for several days. The eruption resulted in massive lahar flows (a mixture of ash, lava, rock and water), primarily in the Rio Montana and Marker watersheds. Montana, a steep stable mountainous river at its pipeline alignment, was transformed into a virtual moonscape due to

erosion or deposition across its alluvial delta into the Rio Quijos.

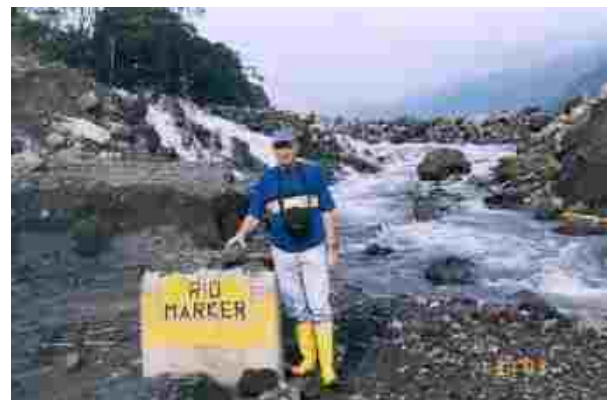
Rio Marker after the Eruption. Bridge deck below the concrete abutment marker.

In the area of the Marker River crossing, the main highway bridge was completely buried by the deposited material.

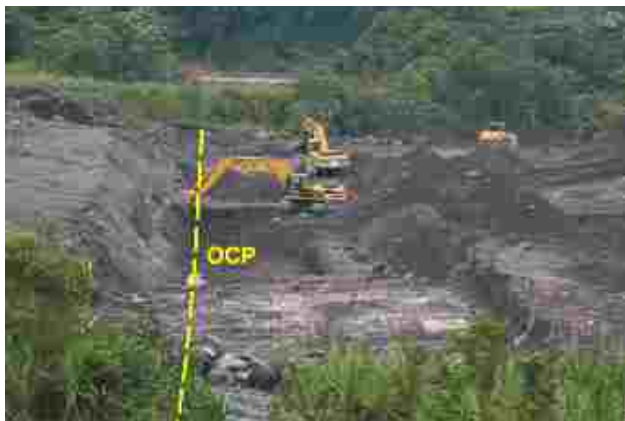
Rio Marker, Excavation for the Pipeline Ditch.

Burial depth criteria were established by Hydroconsult to ensure the OCP line was placed a minimum of 3 metres into the pre-eruption ground elevation. This provided the necessary pipeline cover in the event of scour – zones of deposition and scour in an alluvial fan are variable from event to event and even within the timeframe of a single event – but excavation depths up to 10 m required multiple passes of large excavation equipment.

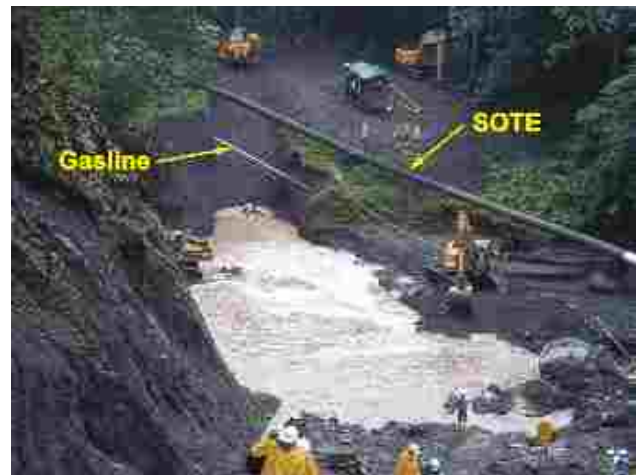
Construction of Rio Reventador crossing complicated by proximity of existing high pressure lines.

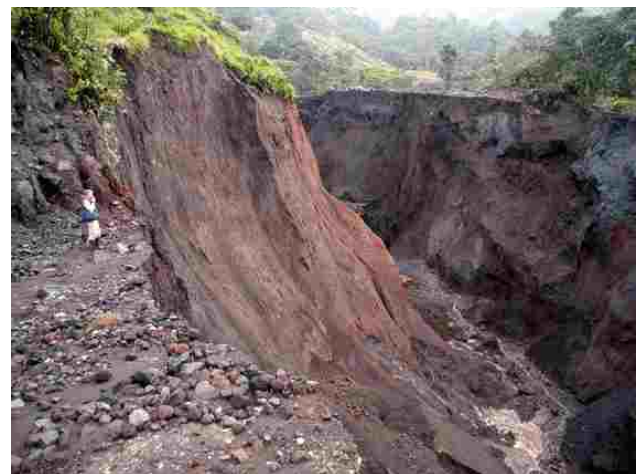
Erosion of Main Highway as a result of overflow from Rio Reventador. Note man at left for scale.

The May 5, 2003 lahar flows on Rio Reventador resulted in the complete disappearance of the highway bridge, the erosion of a 30 m deep canyon into the highway approaching the bridge

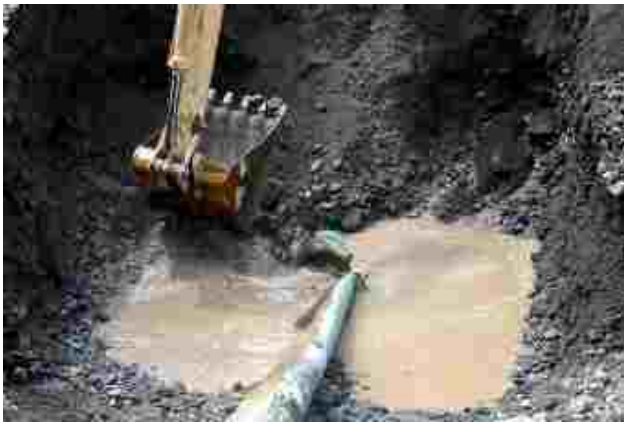
Rio Reventador, Damaged OCP Pipe due to May 5, 2003 Flood

Hydroconsult attributed the pipe damage to extreme initial scour, created by flow patterns generated by a sharp, high rock point upstream. This theory was supported by no evidence of pipe exposure in the remainder of the crossing. In conjunction with TECHINT and OCP, Hydroconsult evaluated alternative designs and alignments from technical and construction viewpoints – the proximity of the SOTE oil line and a gas pipeline made construction in this steep walled valley very difficult.

The uncertainties associated with the influence of the rock point on scour resulted in a realignment and reconstruction of OCP downstream. The redesign was done concurrent with construction in order to meet the overall schedule of the OCP line.
